Transportation Safety Board  
of Canada

**AVIATION**

# REFLEXIONS

Issue 24

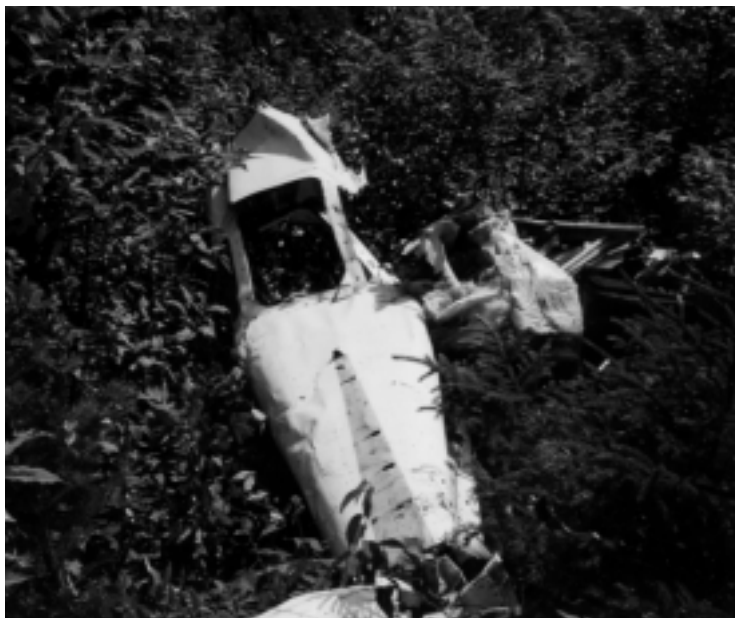
*The pilot of this Cessna 210 tried to squeeze between thunderstorms, but the aircraft broke up in midair.*

Failure analysis suggests that the right wing fractured first, just inboard of the strut joint. The wing then struck the fin and the right horizontal stabilizer, which then failed.

extended too far north-south), and since the aircraft did not have weather radar or a Stormscope storm detector, it would have been appropriate to wait on the ground until conditions improved.

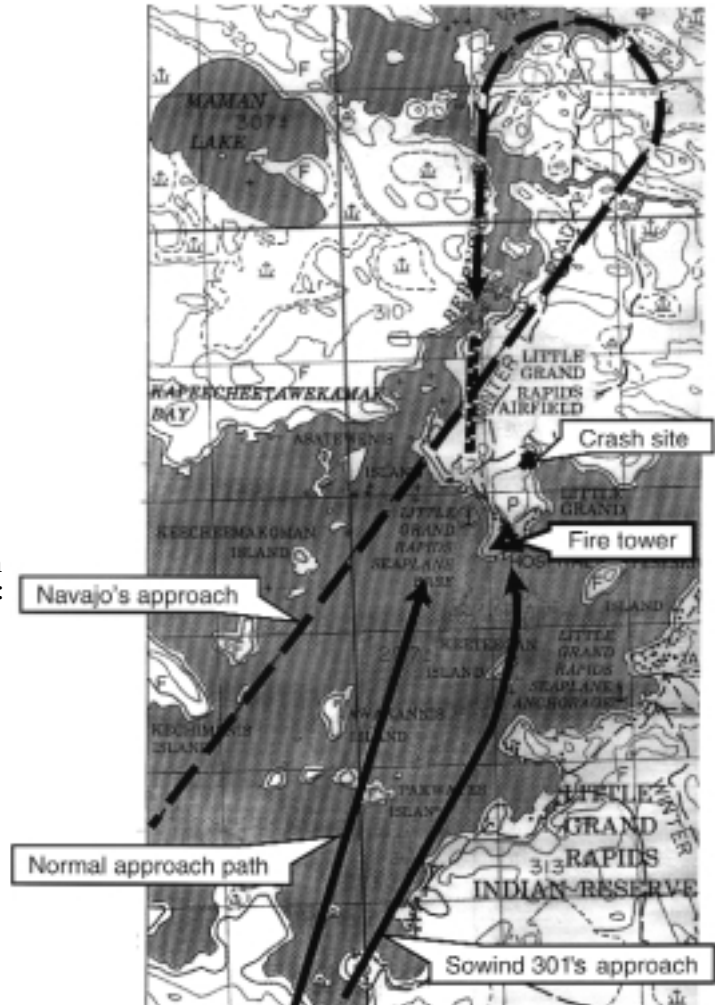
It is reasonable to conclude that the information provided by the Navajo pilot influenced the Bandeirante captain's decision to attempt a second approach. The captain had a reputation for "pushing the weather". The knowledge that a company aircraft had just landed was likely a factor in his decision to descend below the MDA and the minimum altitude for commuter operations and attempt a visual approach in marginal conditions.

*The captain of the aircraft involved in this occurrence had a reputation for "pushing the weather". The approach was conducted below the MDA for the NDB approach.*

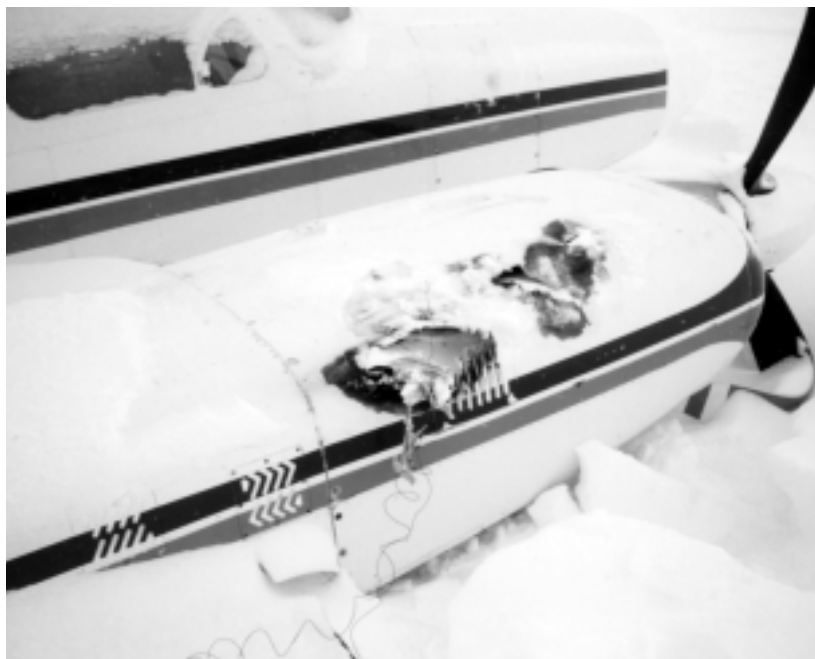
The investigation revealed that the exhaust muffler on the right side of the engine and the exhaust pipe became disconnected because two stainless steel collars were installed on the far aft side of the No. 5 cylinder exhaust pipe to prevent the exhaust muffler from coming into contact with the No. 5 cylinder baffle. The technician who performed the installation did not deem that there was a risk in making that modification.

Following the accident, the exhaust muffler and exhaust pipe were found butted up against each other, jammed together end-to-end, with only about half their respective diameters connecting. In this position, the

exhaust gases could not be expelled normally and were projected onto the end of the exhaust muffler, then directly onto the engine cowling. The exhaust gas temperature was estimated at approximately 1,400°F (760°C). The fibreglass cowl skin could not withstand such high temperatures and was melted by the flames. With the two stainless steel collars positioned as they were, the exhaust muffler could only be inserted less than 1/4-inch (.63 cm) over the pipe; these parts were designed to overlap by more than 1 1/2 inches (3.8 cm) into one another.

*Modifications to the cabin heating unit that were not done "by the book" led to an engine fire on take-off.*

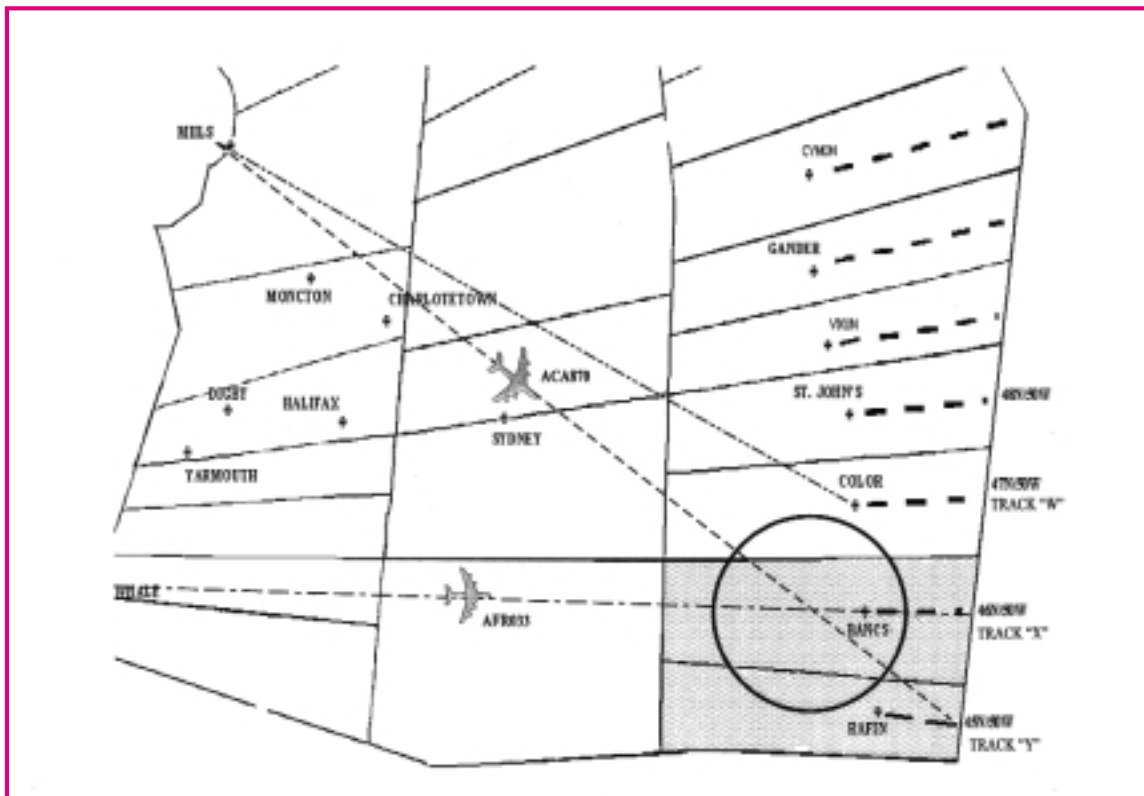
Routes of ACA870 and AFR033. BANCS and south sector shaded.

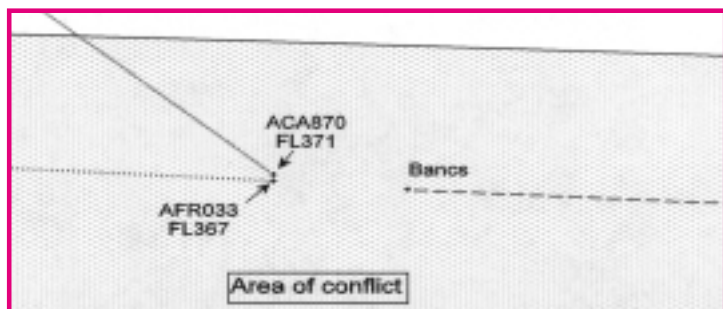
*Aircraft positions at 0212:54. Horizontal distance 1.9 nm, vertical distance 400 feet.*

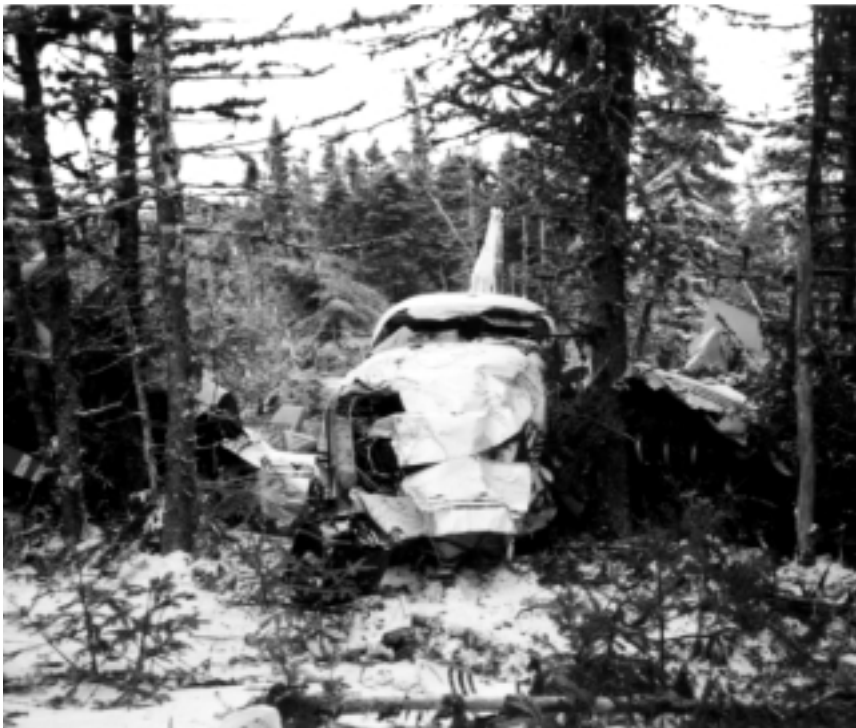
*The pilot of this Aztec had little experience with flight in icing conditions and was surprised at the amount of icing and its effects.*

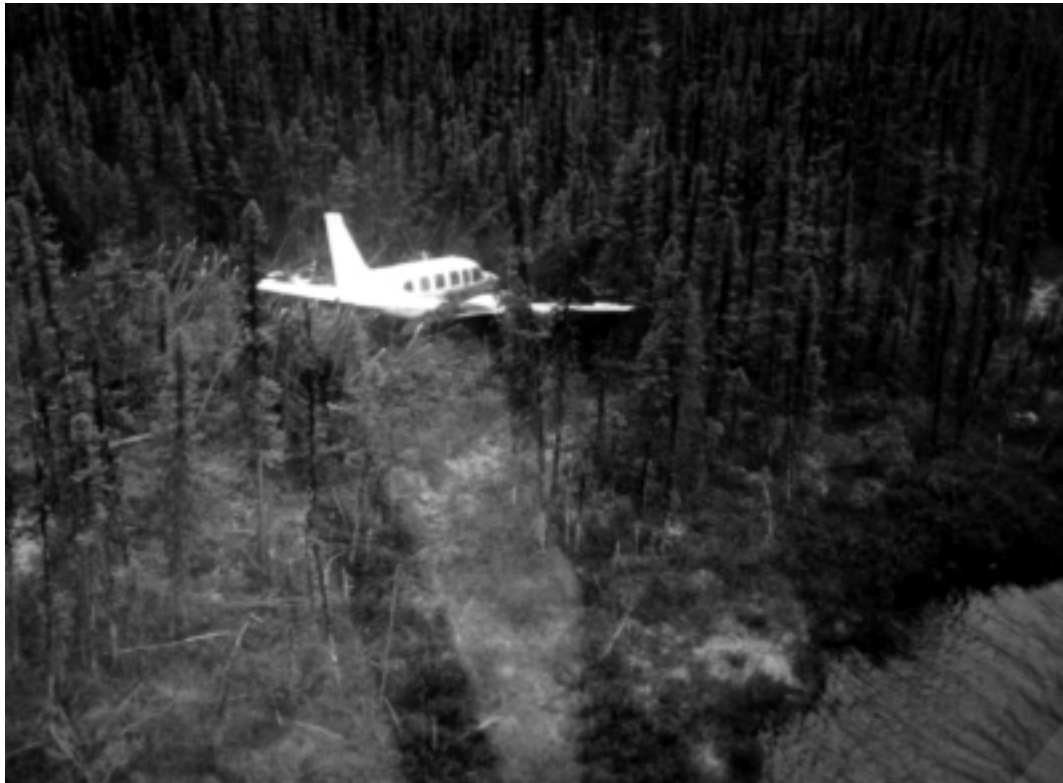
were defective. Although the gauges indicated a steady decrease in fuel level throughout the trip, the pilot-in-command continued to suppose that they were defective and were indicating less than the actual fuel level.

According to the company, the maximum endurance of the aircraft is approximately 4 1/2 hours. The aircraft exhausted its fuel supply after four hours, 39 minutes of flight. The total time includes cruising flight, time on the ground (where fuel consumption is lower), the two take-offs, and the missed approach (where consumption is significantly higher than in cruising flight).

*The Navajo pilot did not believe what the fuel gauges were telling him, and the fuel tanks ran dry.*

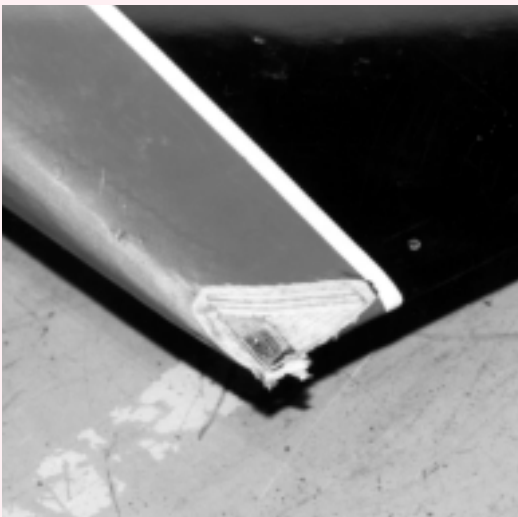
The wingtip scrape that caused this abrasion also weakened the wing spar.

Investigators found a freshly ground-off surface on the bottom side of the aircraft wingtip that was typical of damage resulting from a wingtip contacting the ground during a ground loop or severe swerve to the left. The lack of dirt or debris on the scrape mark indicated the damage occurred from contact with an asphalt or concrete surface. Although it was not possible to quantify the forces applied to the wing as a result of the tip scrape, it was obvious, from appearance alone, that the forces applied at the time of the scrape were sufficient to crack and weaken one or both of the right wing spars. The lack of any sign of rubbing on the fractured surfaces also indicated that any cracking of the wing spars was recent, possibly as recent as the last take-off or landing.

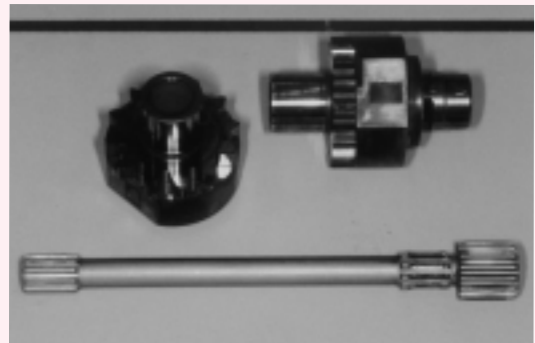
When the No. 1 element drive splines disengaged and the No. 1 element check valve jammed open, pump flow from the No. 2 element recirculated within the pump and little or no fuel flow was provided to the engine. As failed spline pieces jammed between spline remnants in the No. 1 element of the pump, it is likely that momentary power reductions would be followed by short periods of normal power. Eventually, the wear would have progressed to a point that temporary engagement of the drive was impossible and the engine lost all power. The pilot was faced with power interruptions and engine indications that were initially difficult to analyze.

From the crashed Hughes 369HS: No. 1 element drive spur gear (top right), driven spur gear (top left), and the drive shaft with the No. 1 (B) spline worn away.

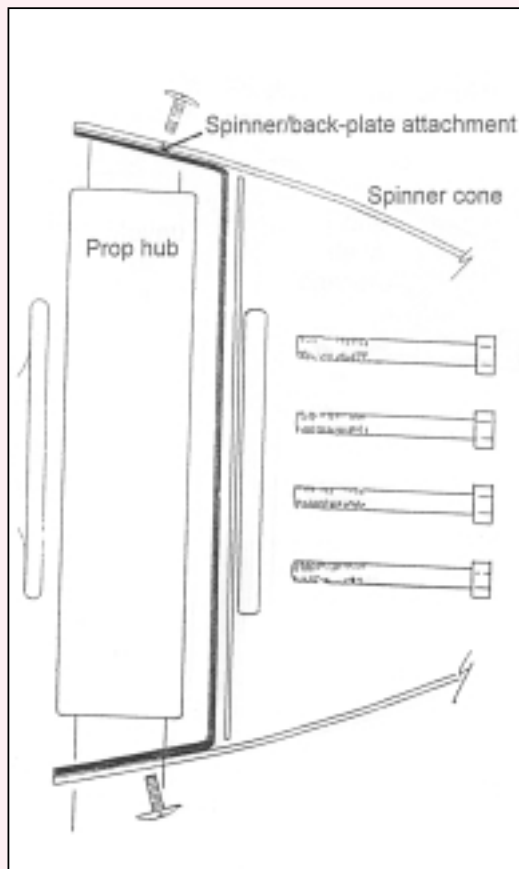
The new spinner separated from the propeller hub just after take-off and passed through the propeller. The spinner may have

Propeller spinner assembly after the accident.

dislodged a portion of the propeller abrasion strip, resulting in a propeller imbalance and a significant vibration. A normal reaction to the noise and vibration would have been for the pilot to retard the throttle.

In this instance, the spinner failed in overload.

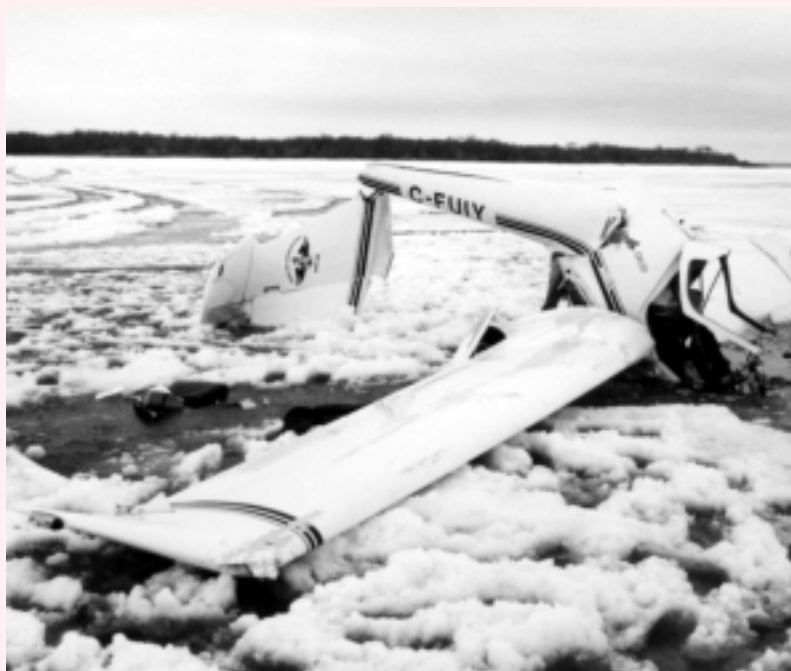
*The pilot lost control of the aircraft in deteriorating visibility and was unable to recover in the altitude available.*
